**HADITHA GENERAL HOSPITAL**  
**UNDER THE ECONOMIC SUPPORT FUND PROGRAM**  
**HADITHA, IRAQ**

**SIGIR PA-08-132**  
**JANUARY 23, 2009**

SUBJECT: Report on Project Assessment of the Haditha General Hospital, Haditha, Iraq  
(SIGIR Report Number PA-08-132)

### **Haditha General Hospital Under the Economic Support Fund Program Haditha, Iraq**

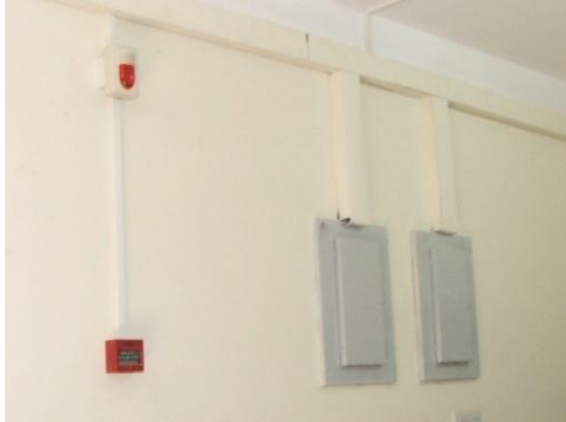
The renovation of the administration wing included an upgrade to the electrical system. SIGIR noted the installation of what appeared to be new wire molding, outlets, light fixtures, and new main distribution panels (MDPs) (Site Photo 7). The MDPs were situated at a reasonable location and were reasonably secure. An intercom system was installed in some areas of the hospital. According to the contractor representative, the system was new; however, due to the careless over-painting of the components, the inspection team could not determine if the equipment was in fact new (Site Photo 8).

**Site Photos 7 and 8. Installation of new wire molding, outlets, light fixtures and new main distribution panels (left) and careless over-painting of intercom system (right).**
